## GEOPHYSICAL ASSESSMENT FOR CHARACTERISING LEAKAGES FROM ASA DAM, NIGERIA

Aeromagnetic and Electrical resistivity tomography technique were used to evaluate the foundation conditions and stability of Asa earth dam located in Ilorin. The Aeromagnetic data set was interpreted to identify dykes, lineaments, and magnetic sources that are controlling the subsurface geology. The extracted lineament structures were employed to examine features that are controlling the distribution of surface and subsurface hydraulic substances which affects the stability of dam. The nature of the magnetic lineaments in some parts of the area suggests rock emplacement under a tensional stress field. Magnetic susceptibilities are not uniform in the area and were categorized viz: high, moderate, and low. The magnetic intensity range at Asa dam is 126.56 to -20.90 nT. The northwestern part of the Asa dam area shows little or no sign of faulting and appears to be more stable structurally than the other part of the study area. Characterization of Asa dam earth embankments for seepage appraisal using resistivity tomography technique revealed that the Asa dam is well compacted with no sign of any seepage. In c

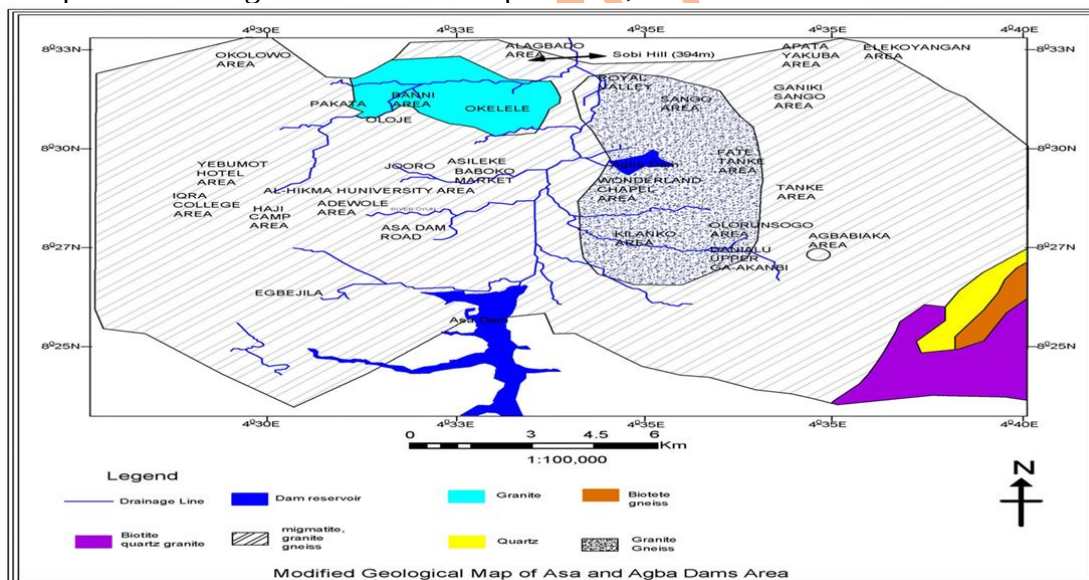
Fig 2: Geological map of the study area (Modified after NGSA, 2017)

it is usually considered to represent the basement complex sensu stricto (Rahaman, 1998; Dada, 2006). Migmatite-gneiss, porphyritic-granite, and quartz veins are among the lithologies recognized from the research area's geologic map (Figure 2).

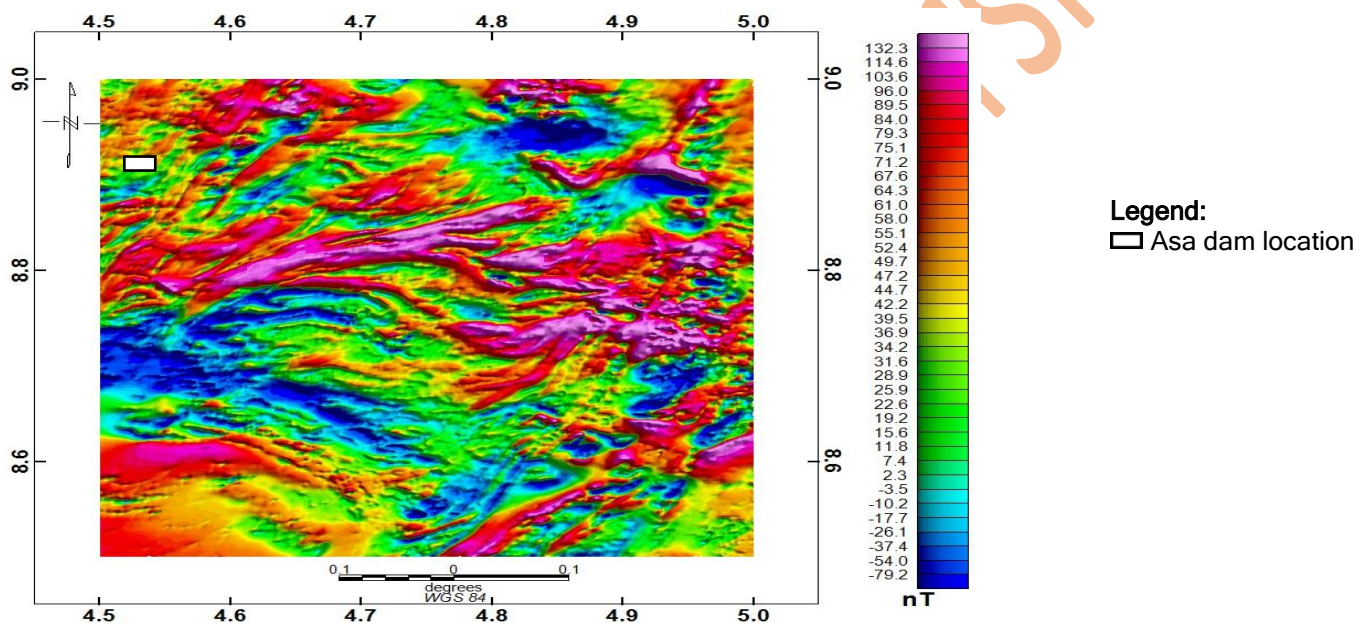
Figure 3: The Residual Magnetic Intensity map of sheet 202

The RMI image obtained from the software shows areas with high magnetic susceptible

indicated by low magnetic values (blue) while areas with less magnetic susceptible are indicated with high magnetic values (pink color). Only the analytical signal image and its reduction to the pole image reveal high magnetic vulnerable locations with high anomaly values. The residual magnetic intensity map for Asa dam (Figure 3) shows that the magnetic intensity values ranged from high (132.3 nT) to low (-79.2 nT). Negative magnetic anomalies were observed in the area, which may be due to the presence of low magnetic rocks like shale, sandstone, limestone which are noted for low magnetic signatures. Removal of the regional magnetic anomaly from the measured anomaly gives negative RMI values.

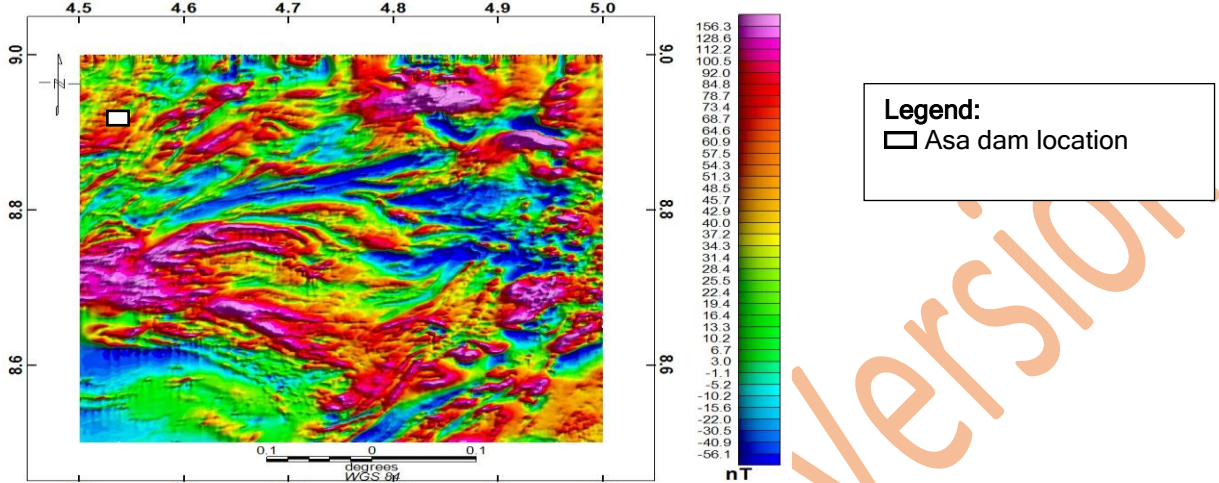
Figure 4: The Reduced to pole map of sheet 202

Figure 4 shows the RTP map of Asa dam area which depicts the frequency variations present in the magnetized rocks of the area. The RTP overlays residual magnetic field anomalies on top of the magnetic field produced by the causative rocks. The areas that were displayed as high and low magnetic anomaly zones in the RMI maps are now shown as low and high magnetic anomaly zone respectively in the RTP maps. Further, contacts between the low and high magnetic susceptible zones have also been enhanced. Various structures such as folds,

faults, and rock lithology contacts have also been enhanced. The majority of low magnetic signatures come from rocks with less magnetic minerals, whereas the high magnetic signature comes from rocks with a lot of magnetic minerals. The study region is located within Nigeria's basement complex, which is characterized by rocks of varied ages and compositions. The area contains rocks such as migmatite, gneiss, granite, granodiorite, and schist. Most of the low magnetic anomalies come from the meta-sediments while high magnetic susceptibilities are from the competent basement rocks. The patterns that were observed on the

RTP map are due to rock deformation especially around the central part of the study area. The basement rocks have been folded during several phases of deformation and these had allowed the magnetic minerals that are present in such rocks to also reshape themselves in the manner that the host rocks have done. The southwestern area of the RTP map (Figure 4) shows moderate

magnetic signature with little or no structures when compared to the rest of the area. The map's orientation is NE-SW, which corresponds to structural tendencies that have been recorded physically on field outcrops and described by numerous researchers on the Nigerian basement complex.

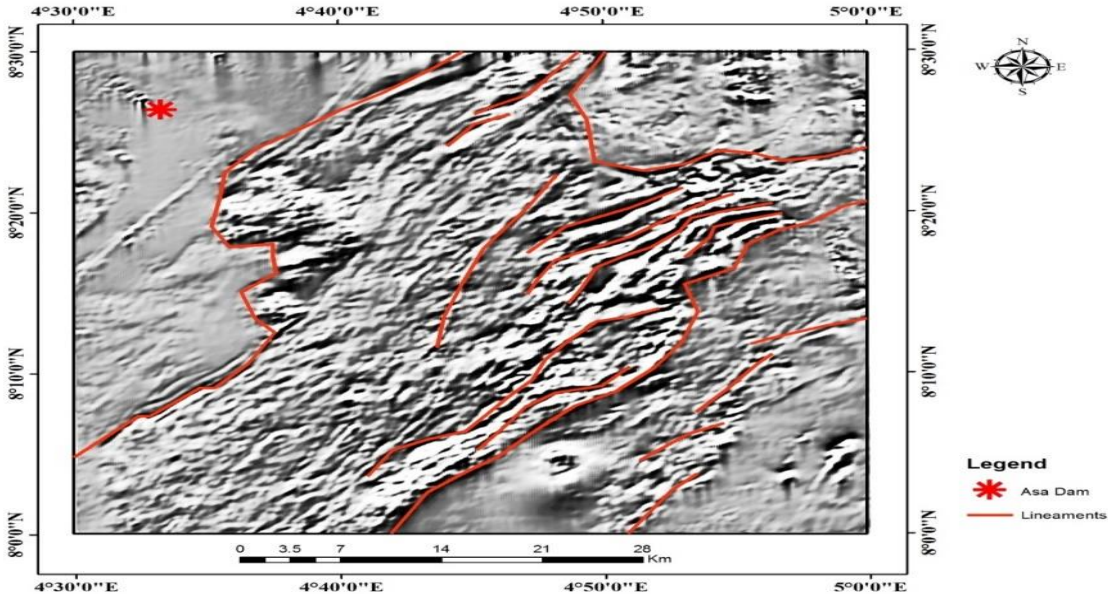
**Figure 5: The First Vertical Derivative map, showing lineaments in Asa dam area**

Figure 5 shows the first vertical derivative map of the study area. The FVD grid was upwardly continued to a hundred meters to subvert the effects of deep source magnetic features and to enhance shallow source magnetic features that are associated with geological structures. Figure 5 shows lineaments, which are structural deformations associated with geological

phenomena such as arching zones and even geological contacts. Magnetic minerals are concentrated along or aligned with certain structures, and lineaments were defined by noticing the sudden change in positive and negative magnetic anomalies. This gives a rough understanding of the research area's structure and lithologic deformations.

The area of study falls within the basement complex of Nigeria that has undergone several episodes of deformation (polycyclic) according to Rahman, 1984. The patterns of folding and faulting observed on the FVD map (Figures 5) were formed during the various episodes of deformation that the basement rocks have undergone. The basement rocks have been folded during several phases of deformation and this has allowed the magnetic minerals that are present in

dam area especially the downstream. As seen in Figure 5, most of the lineaments are concentrated in the mid-part of the area of study and trends in a NE-SW direction. Shearing is also taking place in the middle part of the area of study. The style of folding and faulting in the area of the study suggests this area could be a shear zone i.e. places where several shearing is taking place, and as such is not suitable for dam emplacement without proper foundation treatment. This would however make dam construction in such areas more challenging and expensive. The northwestern part of the Asa dam study area (Figure 5) shows little or no sign of faulting and appears to be more stable than the other area of the map. It is not surprising that the Asa dam had been emplaced in such an area. The area is fairly stable structurally. We could therefore deduce from the above that the Asa dam is located in less structurally active zones and could likely have a functional failure rather than structural because there are no visible geological structures near the dam area.

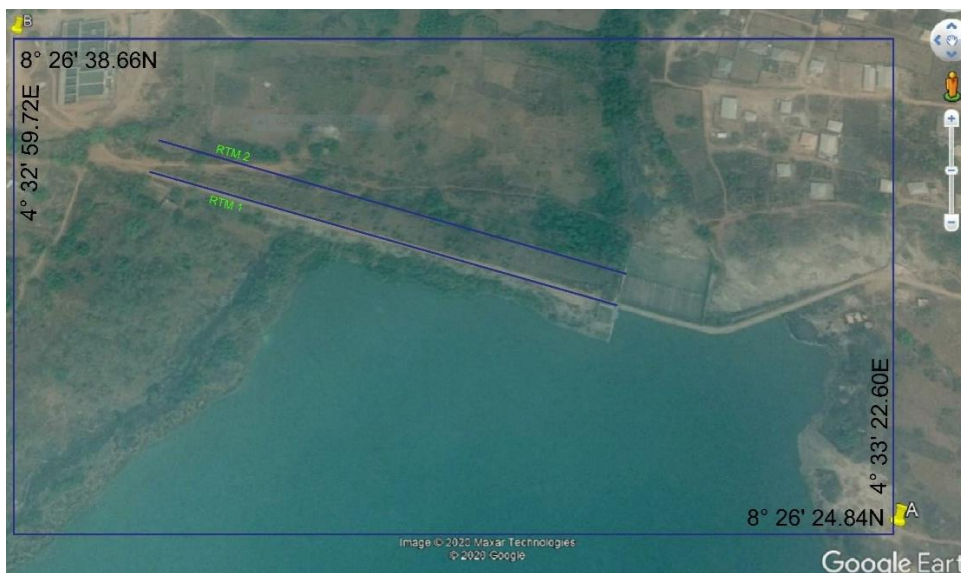
**Figure 6: Asa dam Resistivity Tomography Profile**

The first ERT profile was taken along the downstream sides of the dam around 15 meters from the center, while the second ERT profile was taken near the dam's core. The two ERT

profiles are laid out in a SW-NE direction, beginning at the dam's embankment and ending at the spillway (Figure 6). To acquire better results from noisy data, the obtained ERT data were inverted using the least-squares method, which included smoothing of model resistivity.

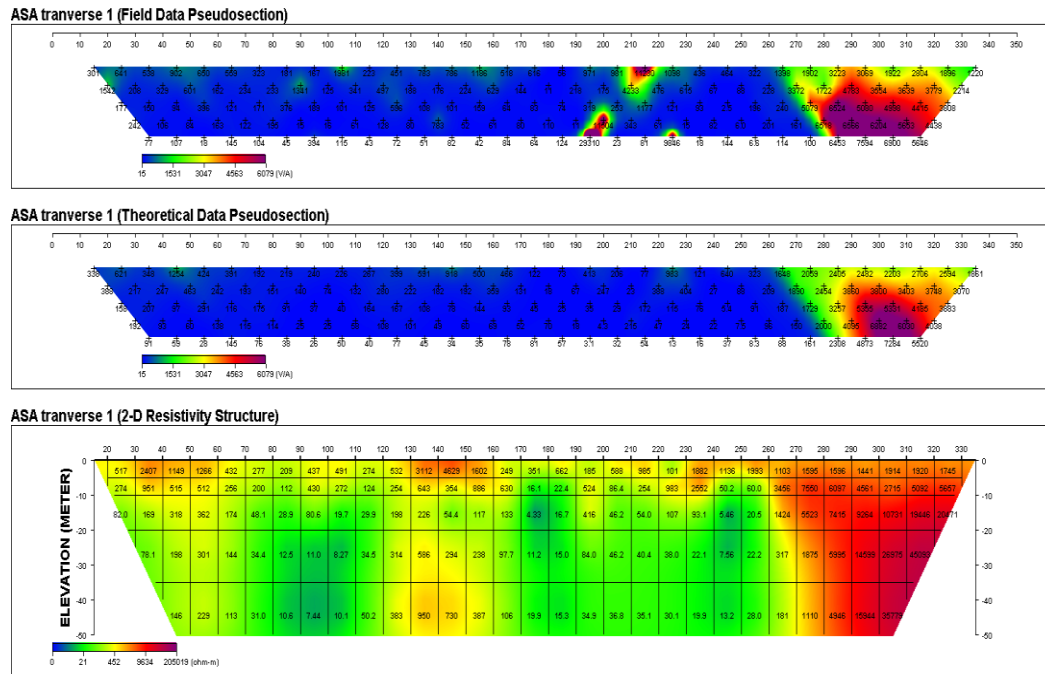
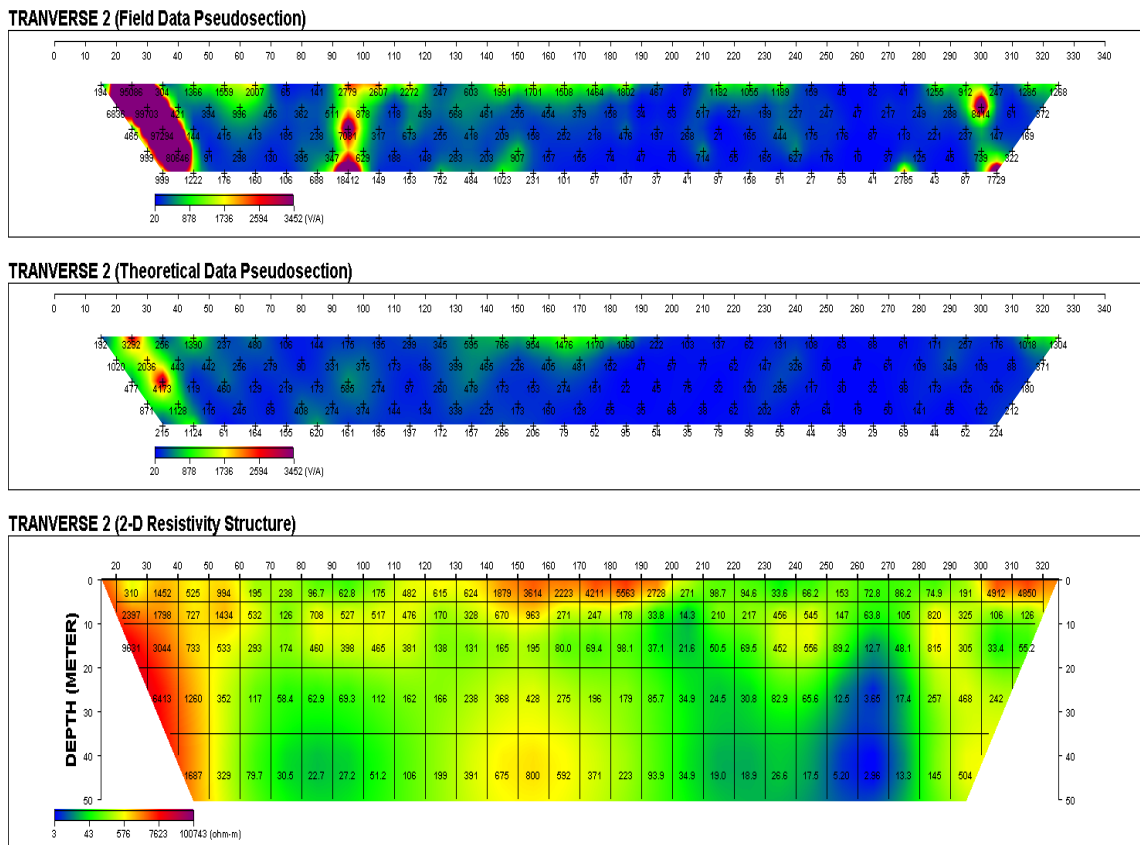
Figure 7: Interpreted geo-electrical section of RTM 1 profile of Asa earthembankment

Figure 8: Interpreted geo-electrical section of RTM 2 profile of Asa earth embankment

Figures 7 and 8 show traverse 1 and traverse 2 pseudo-section of the Asa dam established along the dam embankment. It shows both the

theoretical, field sections, and resistivity structures. It further shows the cross-section of RTM 1 and RTM 2 profile of the subsurface up

to a depth of 50 m. RTM 1 is along with the downstream of the dam embankment while RTM 2 is along the center of the dam embankment. The 2-D resistivity image shows three major resistivity zones; very low resistivity indicated by the blue coloration (depicting overburden and/or seepage zones or water-bearing soils), medium-range resistivity indicated by the green to yellow coloration (depicting lateritic soils, weathered basements, and indurated soil that is relatively impermeable to water), and the high range resistivity indicated by orange to purple coloration (depicting the fresh basement/highly competent rocks).

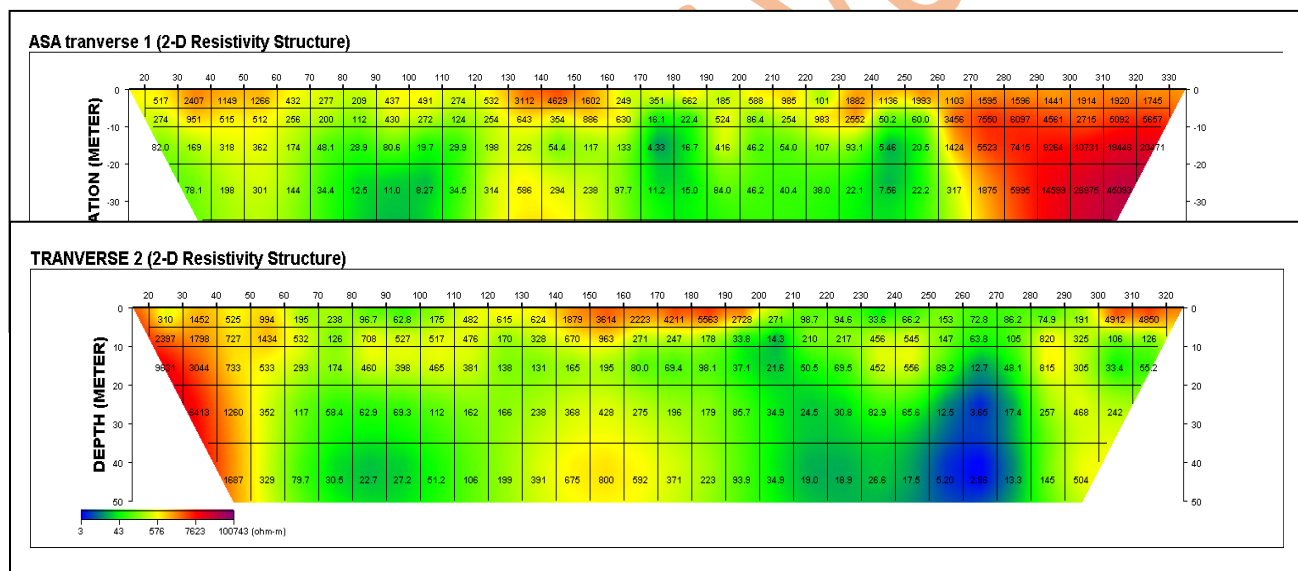
**Figure 9 Correlation of RTM1 and RTM2 of Asa earthdam embankment**

Figure 9 correlates the resistivity of RTM1 and RTM2 of the Asa earth embankment. The dam is well compacted at the surface which shows high resistivity values from the surface and relatively throughout the dam embankment. A relatively

low resistivity zone is observed around chainage 250 to 270 commencing from around 15 m depth indicating weakness and or water-bearing zone. This location is observed to be the sand filter zone which is used in collecting the excessive underground water and water percolation in the semi-permeable zone of the composite earth dam. This does not affect the integrity but enhances the stability of the dam embankment and foundation. It could be observed that this is only noticed at the downstream section (RTM 1) of the earth embankment whereas the center (RTM 2) of the dam embankment at this section is highly indurated with no visible sign of water.

Characterization of the Asa dam subsurface for seepage appraisal using resistivity tomography technique on the other hand revealed that the dam is well compacted and highly indurated at the surface and at depth, which shows high resistivity values from the surface and relatively throughout the dam embankment.
