## DEVELOPMENT OF A GREENHOUSE ROOF CLEANER

Y. Mijinyawa and T. D. Akpenpuun

Department of Agricultural and Environmental Engineering,  
Faculty of Technology, University of Ibadan, Ibadan, Nigeria  
Email: [mijin1957@yahoo.com](mailto:mijin1957@yahoo.com)

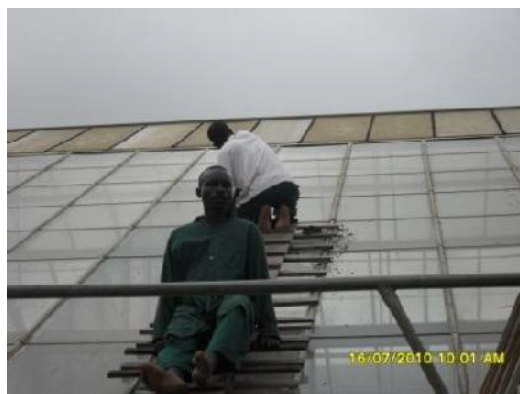
Fig 1. Manual Cleaning Procedure at the International Institute of Tropical Agriculture (IITA), Ibadan, Nigeria.

The cleaning of greenhouse roofs could be done manually using ladders or automated using the roofmaster (Fig 1 and 2). As a result of cost and high technology involved, the roofmaster is more restricted to advanced countries while the manual method is the one commonly used in many developing countries, especially Nigeria. The manual method does not only endanger the labourers, it is both time consuming and labour intensive, and exposes both the greenhouse glazing and framing to damage arising from imposed live load from the ladders and workmen. For these reasons, many greenhouse roofs are hardly cleaned.

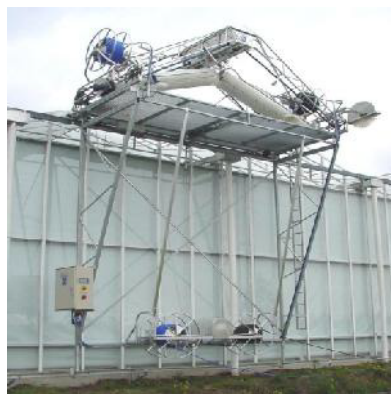
Fig 2. The Roofmaster

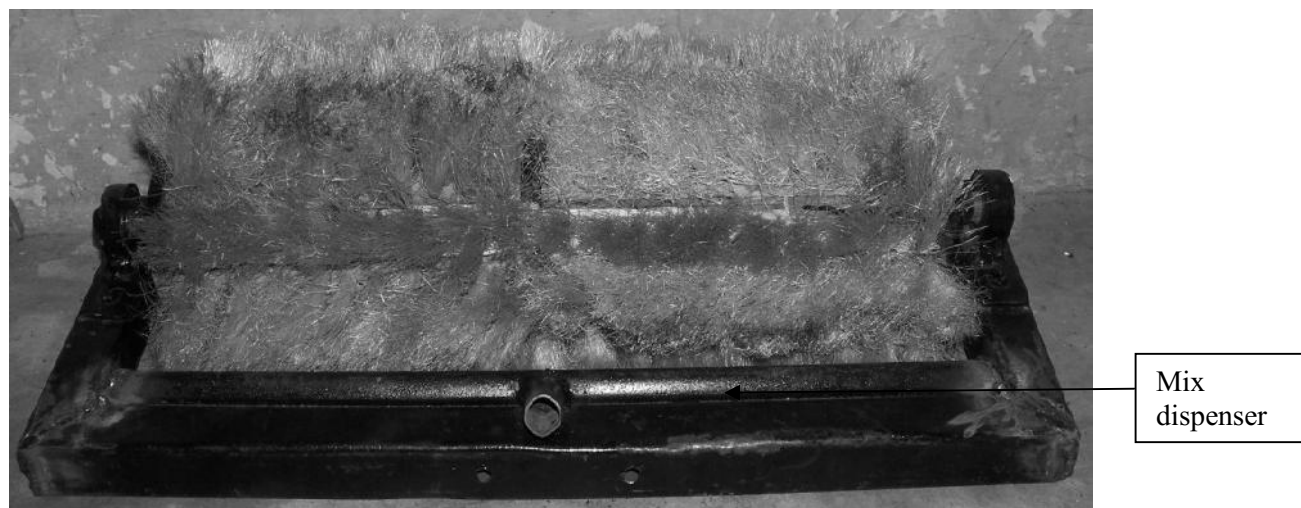
Fig 4. The Brush

Aluminum hollow pipe of square dimension was cut to 610mm and 305mm lengths for the fabrication of the brush frame using an arch saw. The brushes were attached to the aluminum frame using 10cm bolts and nuts. The shaft was fabricated from 6.23mm diameter solid steel rod and was welded to the frame to provide the rotational motion of the brush. Because of the initial cutting forces of the arch saw, welding operation and bolting of the brush to the aluminum frame, the brush assembly was balanced on a balancing machine in order to detect the amount of unbalance in the brush. The amount of unbalance detected was corrected by grinding and filing edges and joints. The mix dispenser is a 610mm long and 19.05mm diameter pipe with 2.54mm diameter holes perforated along its length for proper dispensing of the cleaning mix to the brush. The brush is shown in Fig 4.

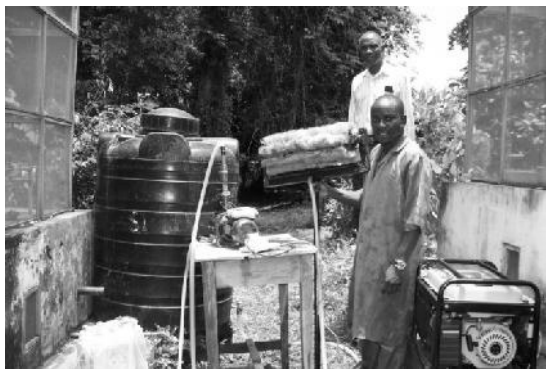
Fig 7. The Cleaning Set-up

The water tank within the greenhouse was filled with water, the water pump was connected, the solution dispenser was plugged to the water source while a stand by generator was available in the event of failure of public power supply. This set-up is shown in Fig 7.

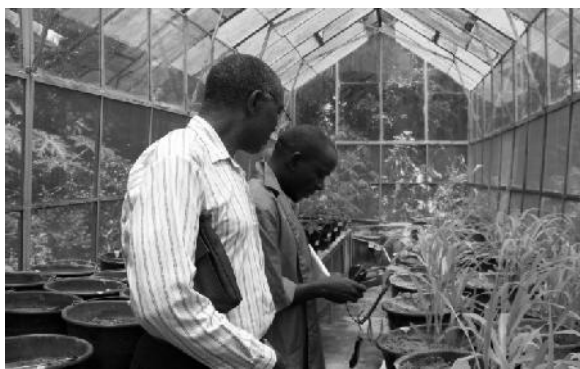
Fig 8. Recording Light Transmission inside the Greenhouse

The incident light illumination was taken at various locations around the green house which were then averaged to know the incident light in the environment. The light intensity within the greenhouse was measured at six locations. Repeated readings were taken and later averaged as shown in Fig 8.

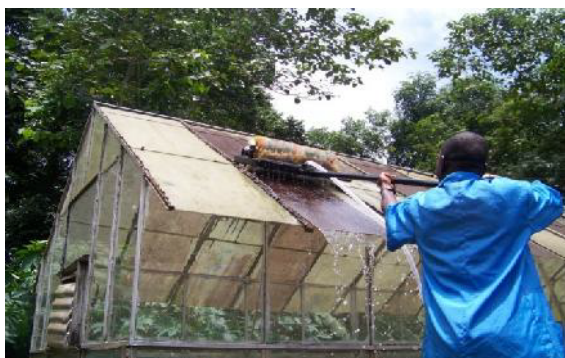
Fig 9. Greenhouse Roof Cleaning using the Designed Cleaner

Cleaning was done from the ridge down to the eave while the workman stands on a scaffold. The washing mix was pumped to the mix dispenser with a dispensing hole of diameter 6.05mm. Three bays could be washed from one standing position of the scaffold. The set-up was moved to adjacent bays until the entire roof was washed. The washing process is shown in Fig 9.
